Technical Inspection Report
Bureau of Ordnance Group

6
OPERATION CROSSROADS.

TESTS 'A' AND 'B'.
VOLUME IV.
PART X. PHOTOGRAPHIC
APPENDIX [U].

GUNS AND MOUNTS PHOTOGRAPHIC INDEX

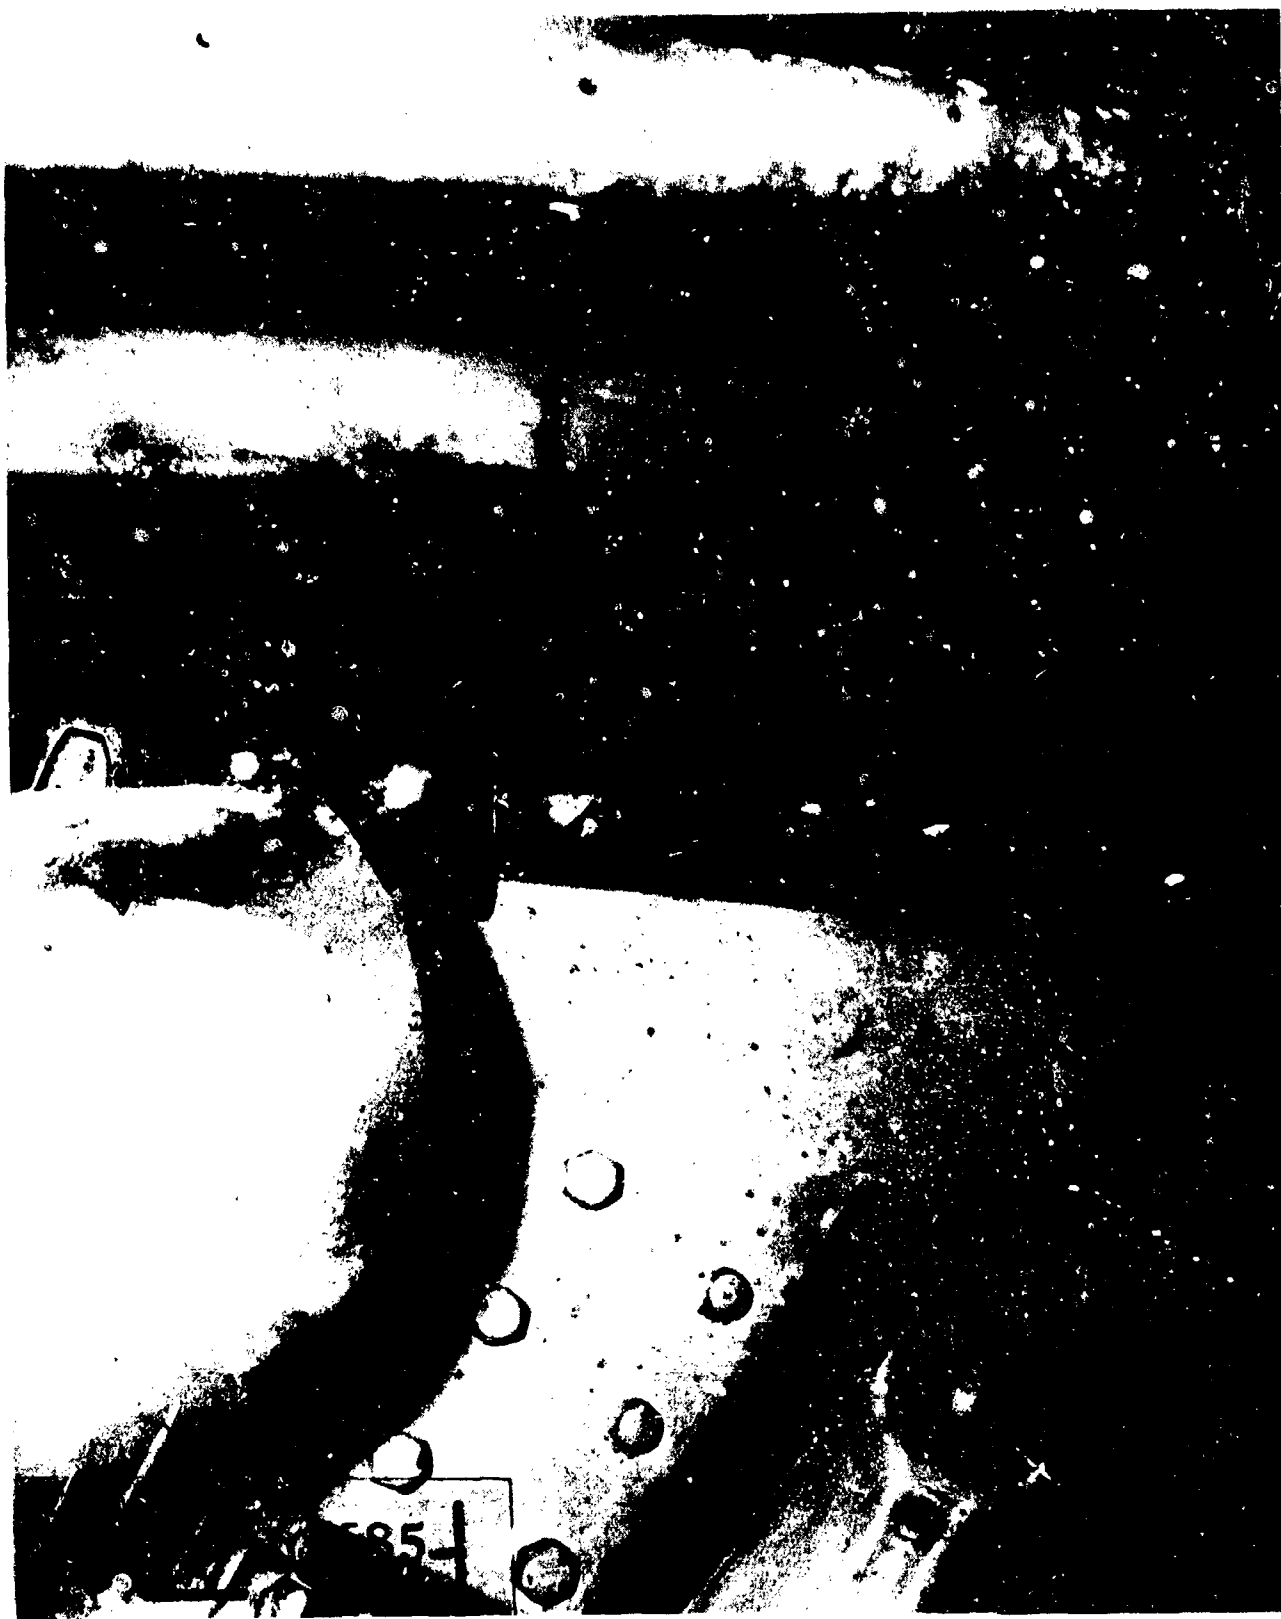
U.S.S. PENSACOLA (CA-24) - After Baker
Close up view of the Mechanical Train
Indicator Gear, Mt. No. 2. Showing how
much it was disengaged from the rack and
the exposed balls and race.
Photo. No. AB-CR-97-1685-4.

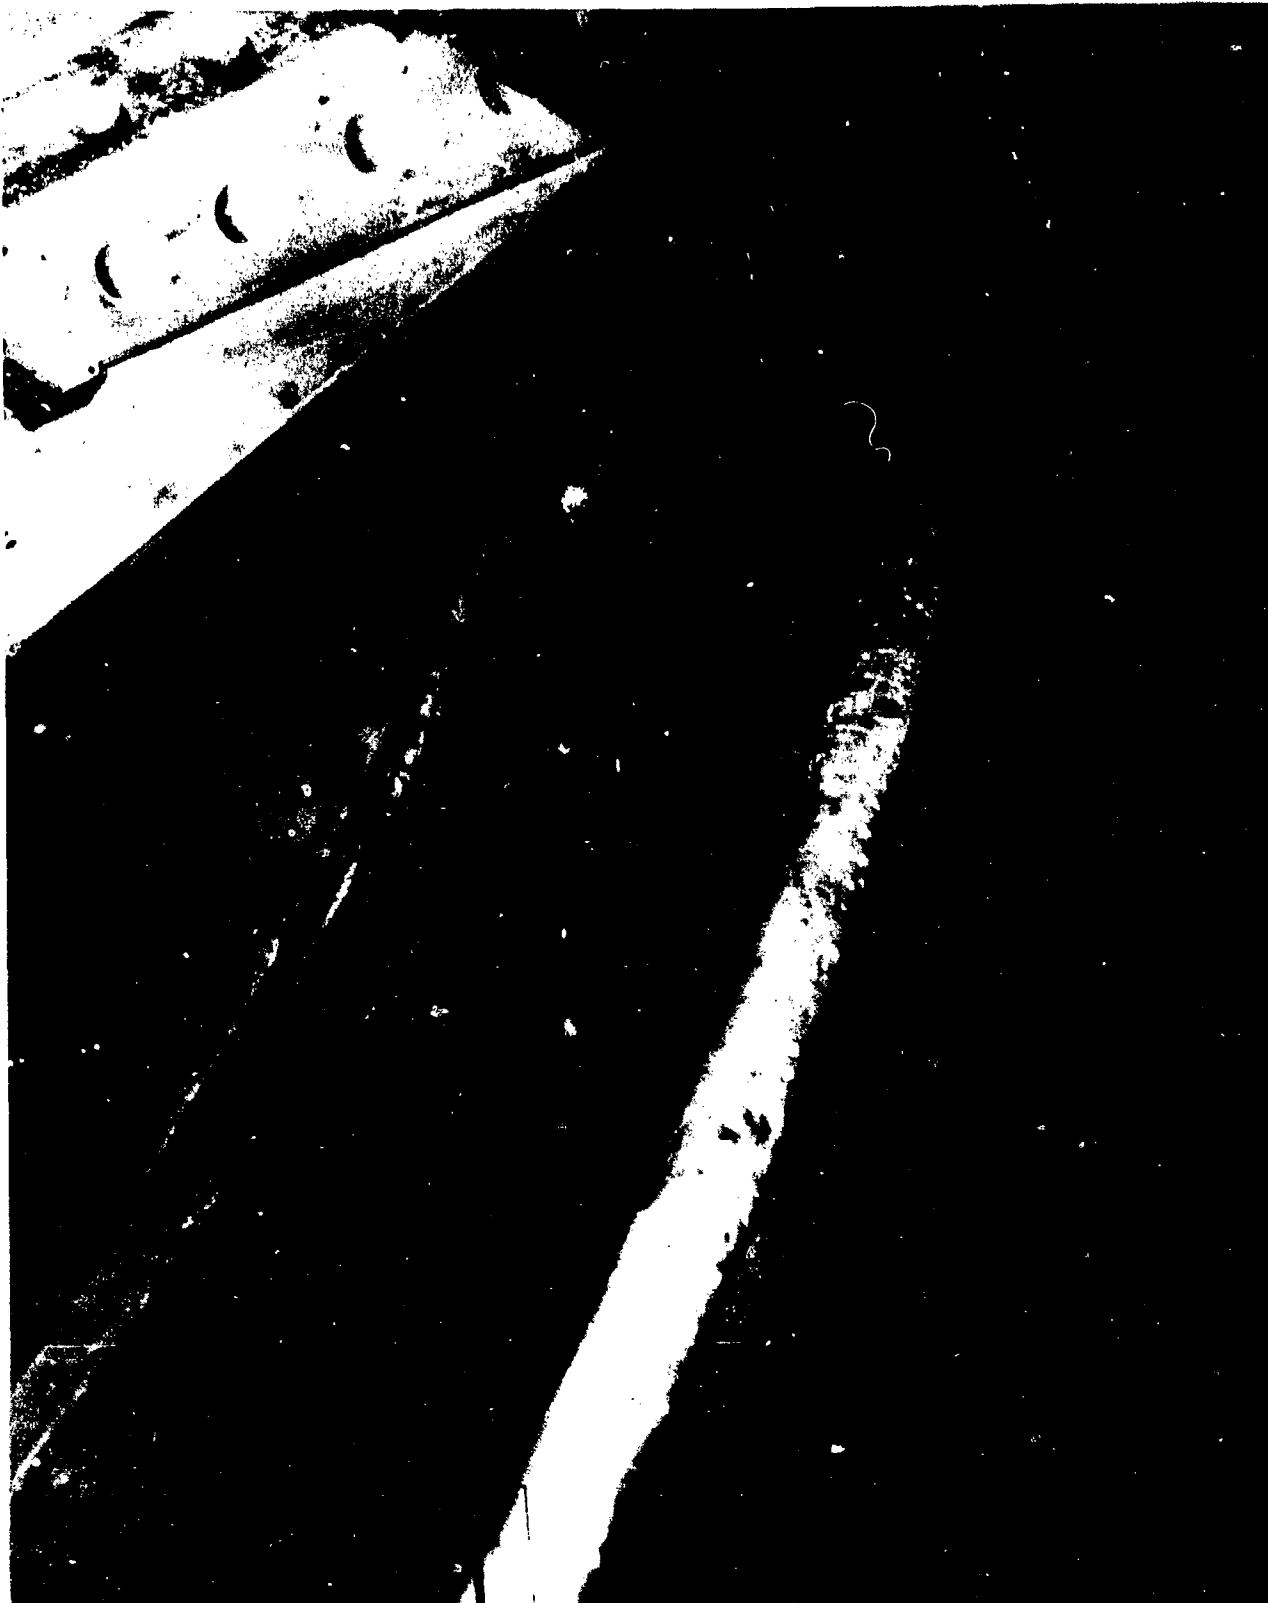
U.S.S. PENSACOLA (CA-24) - After Baker
Close up looking up at the training rack
stbd. fwd. in Mt. No. 2. Showing the
torn flange under the training rack.
Photo. No. AB-CR-77-1685-6.

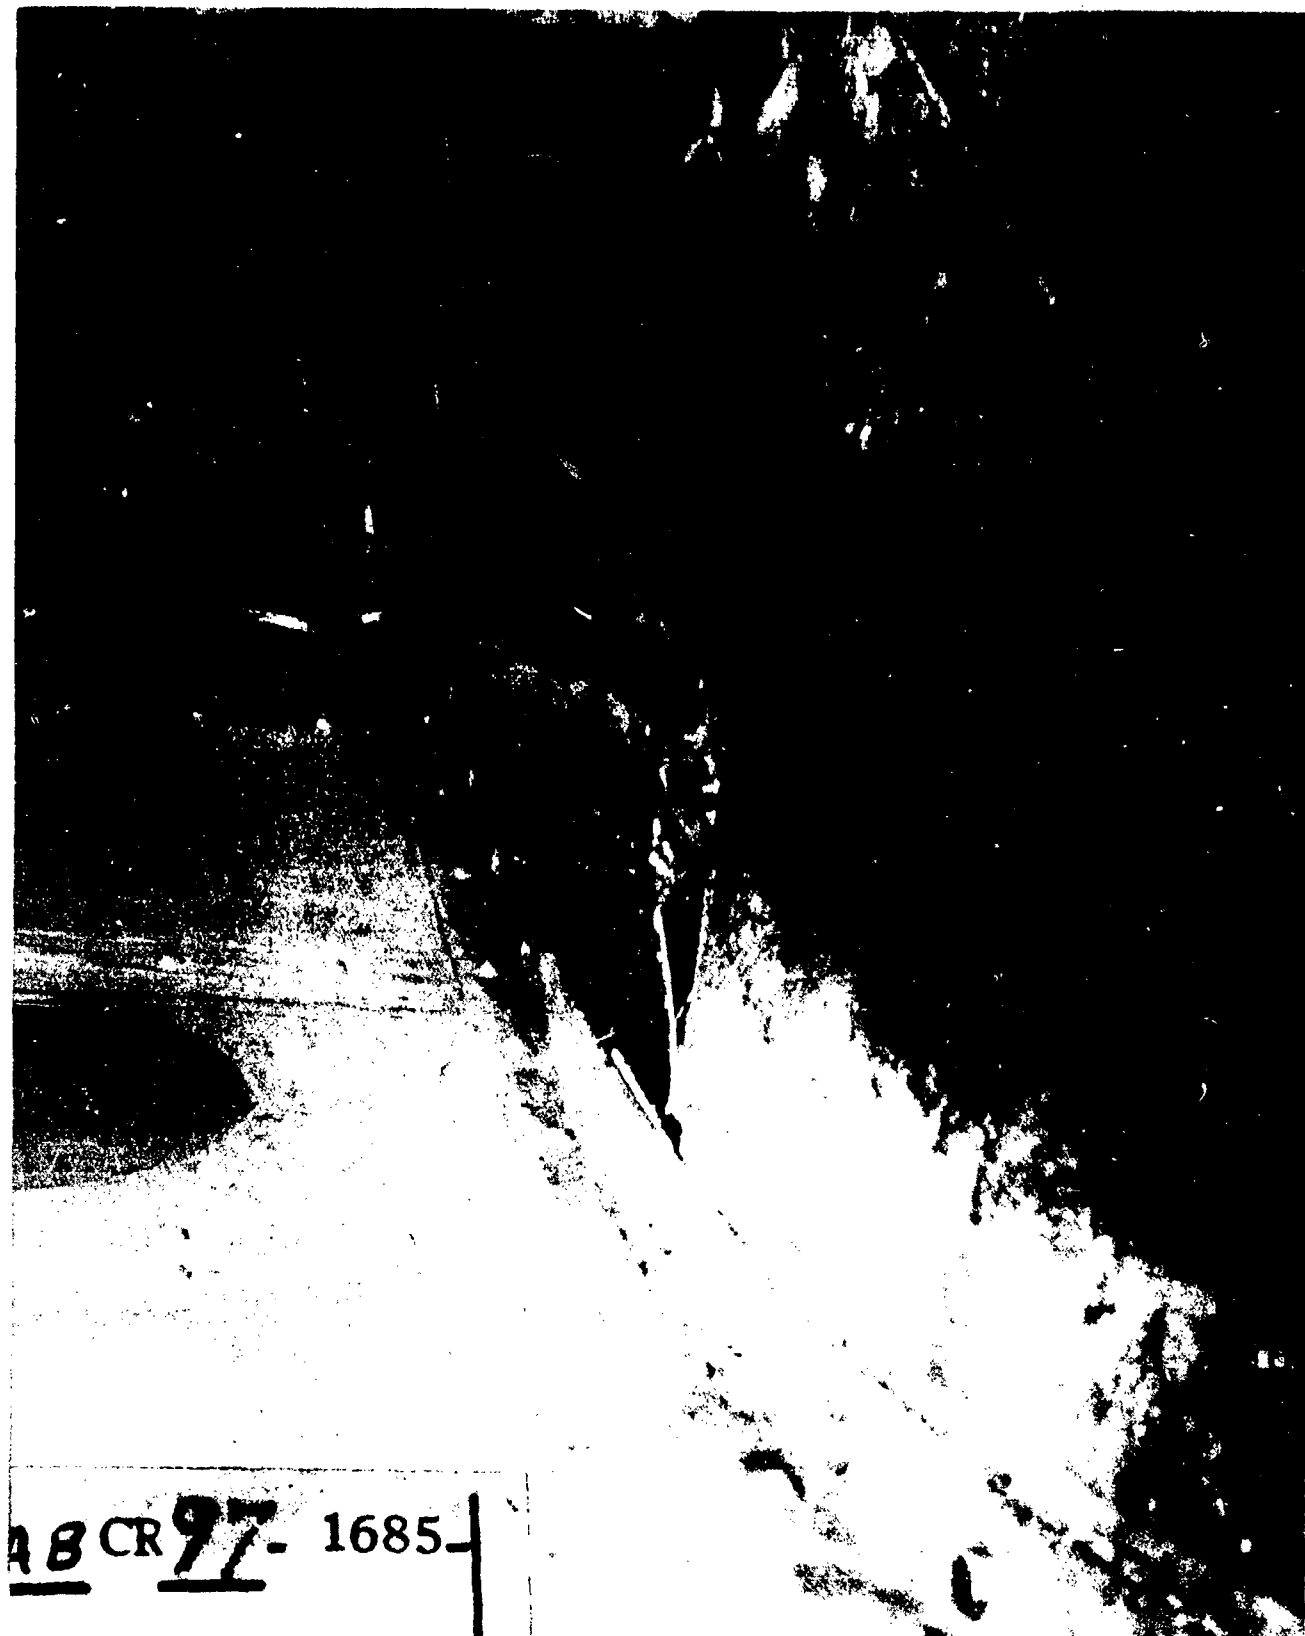
AB CR 97- 1685-

U.S.S. PENSACOLA (CA-24) - UPPER DECK
General view of upper powder transfer room
8"/55 Mt. No. 2. Showing buckled deck on
after side of the powder transfer room.
Photo. No. AB-CR-97-1685-8.

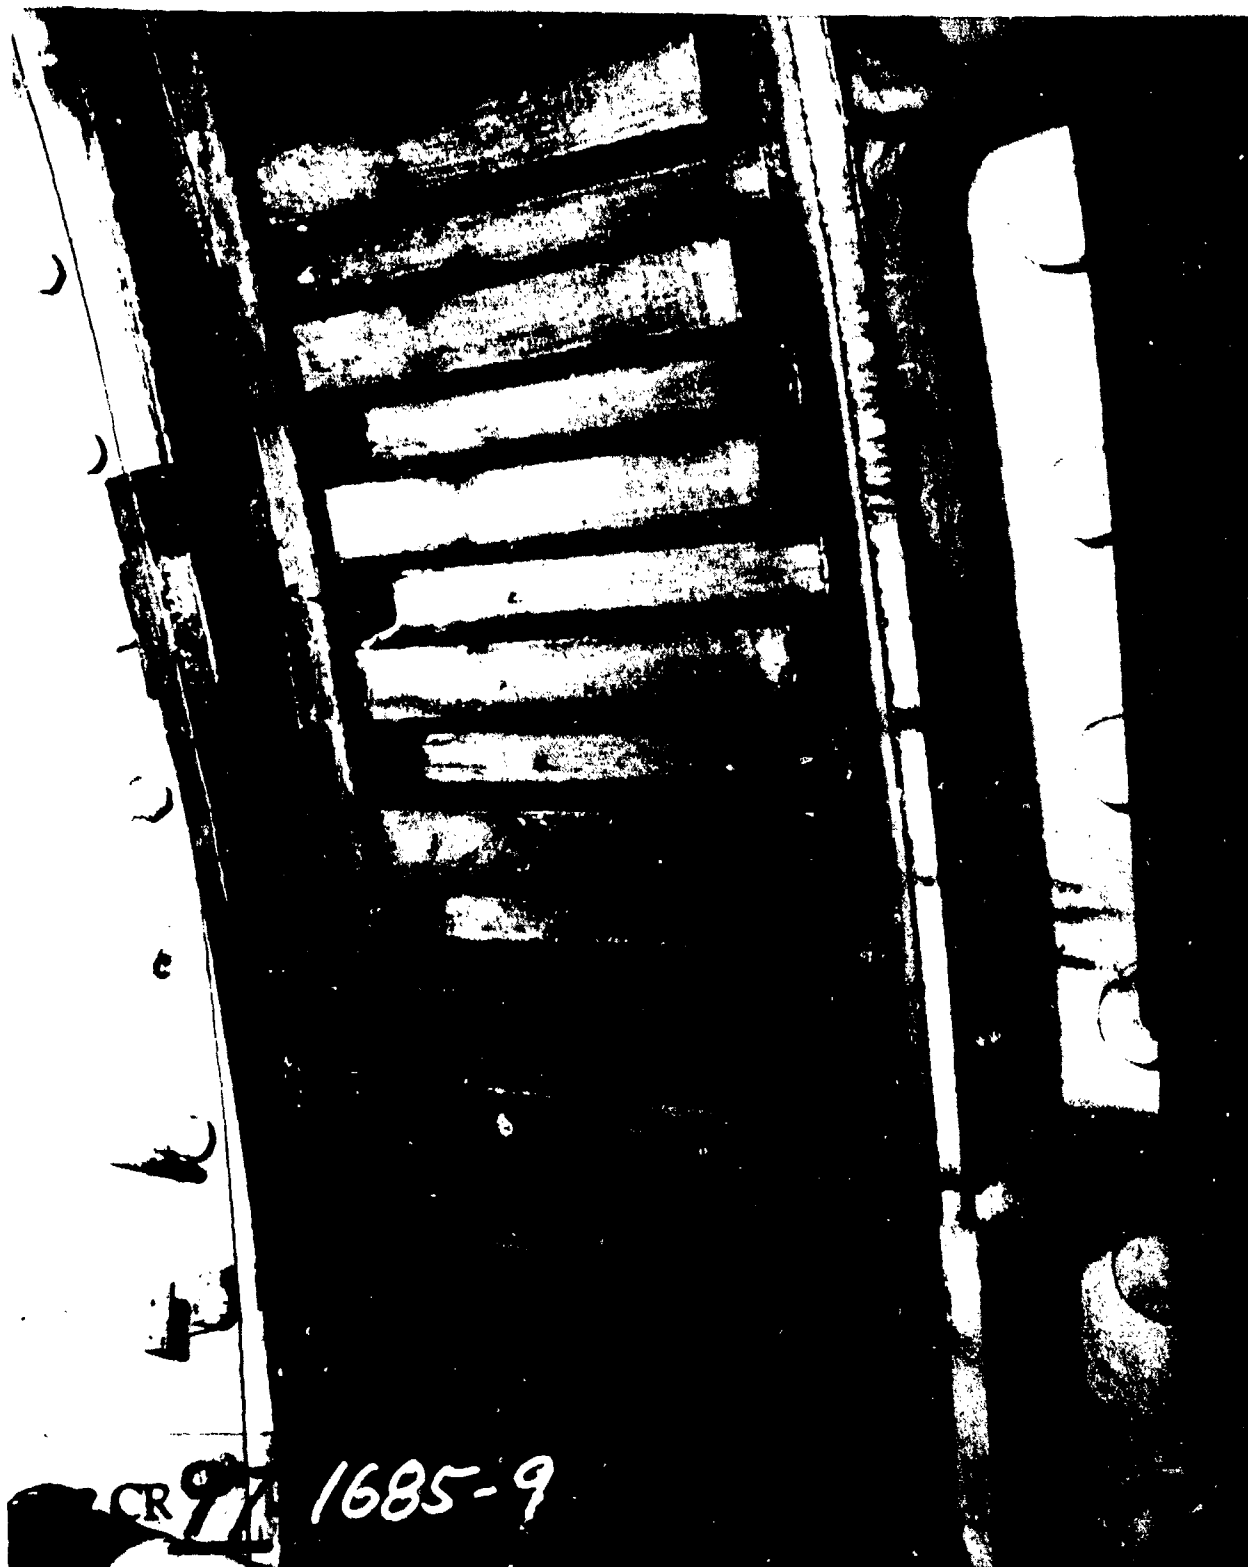
U.S.S. PENSACOLA (CA-24) - After Baker
Close up of training rack and balls and ball
race on after center line side of 8"/55 Cal.
Mt. No. 2. Showing exposed ball race and
displaced balls and how much the sections
overlapped.
Photo. No. AB-CR-97-1685-9.

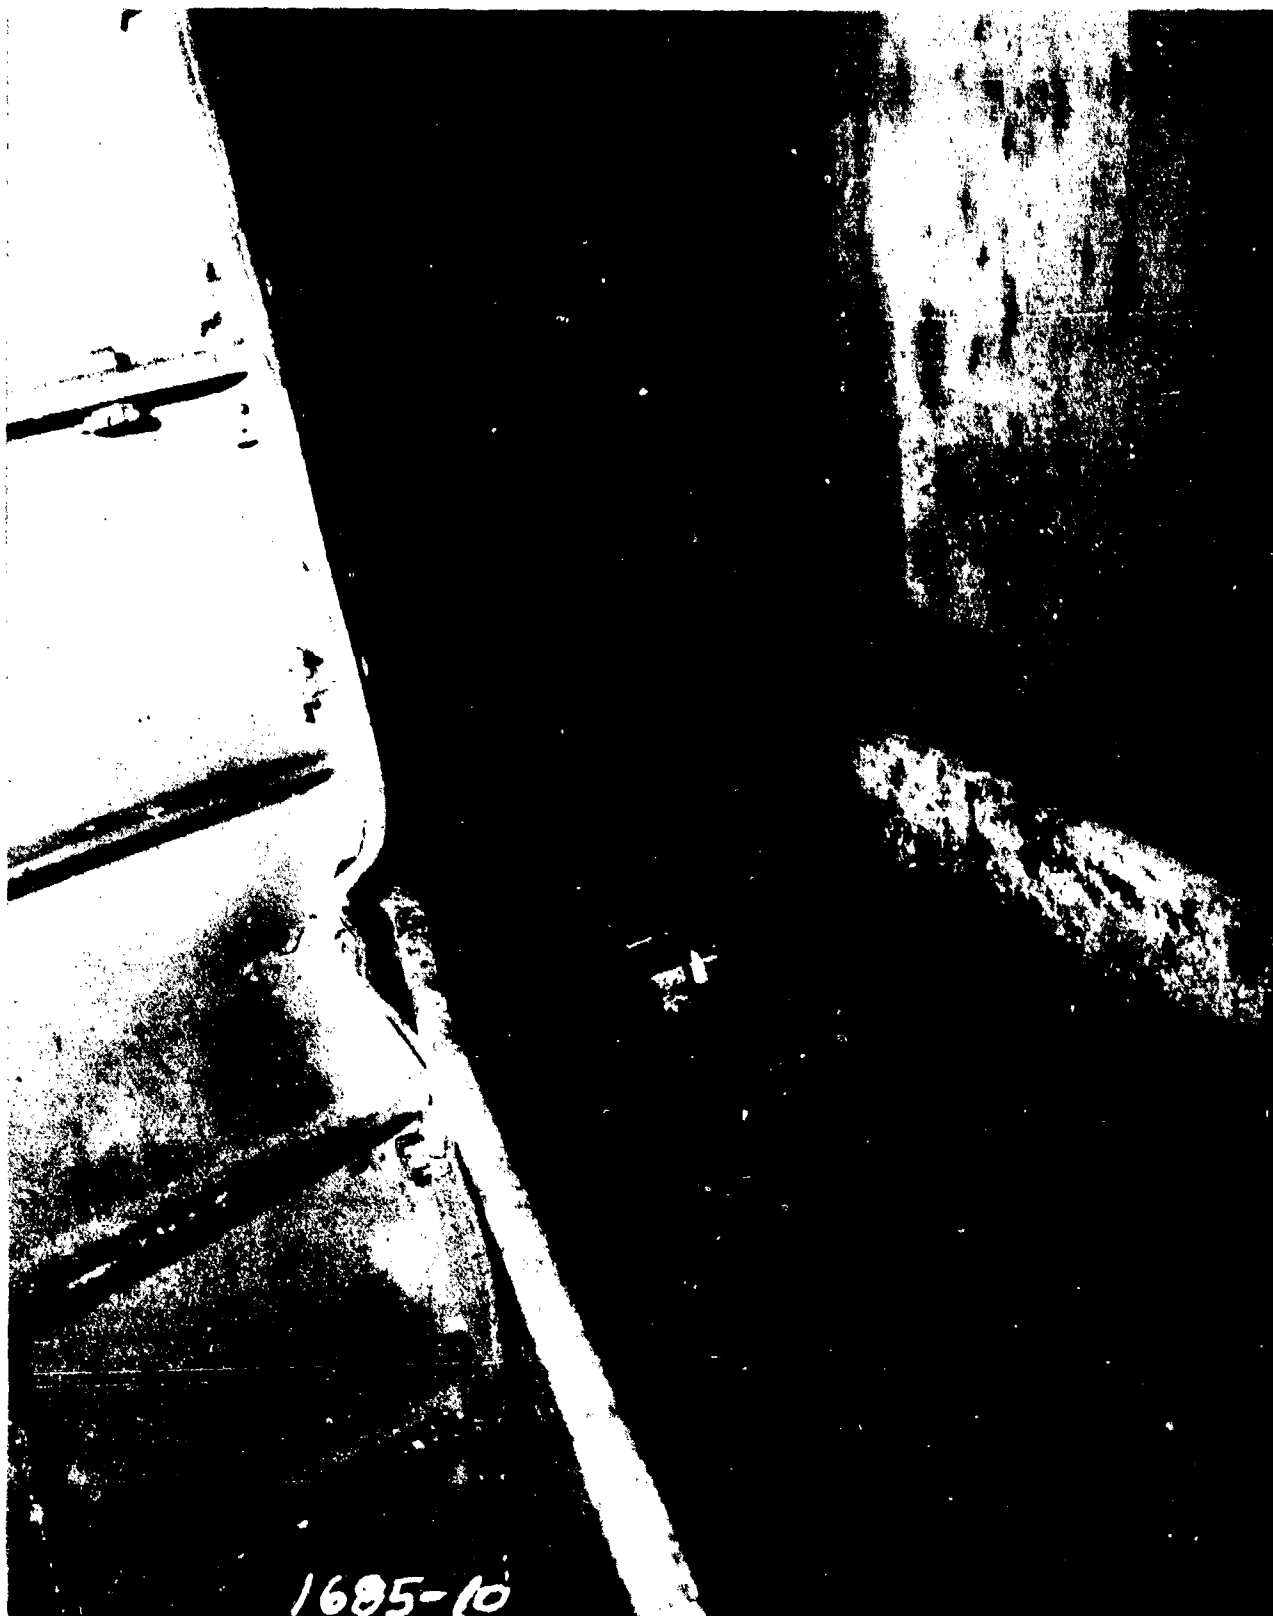
U.S.S. PENSACOLA (CA-24) - After Baker
Close up view of left side of powder transfer
room 8th/55 Mt. No. 2. Showing dent in powder
trunk and bent transfer tray.
Photo. No. AB-CR-97-1685-10.

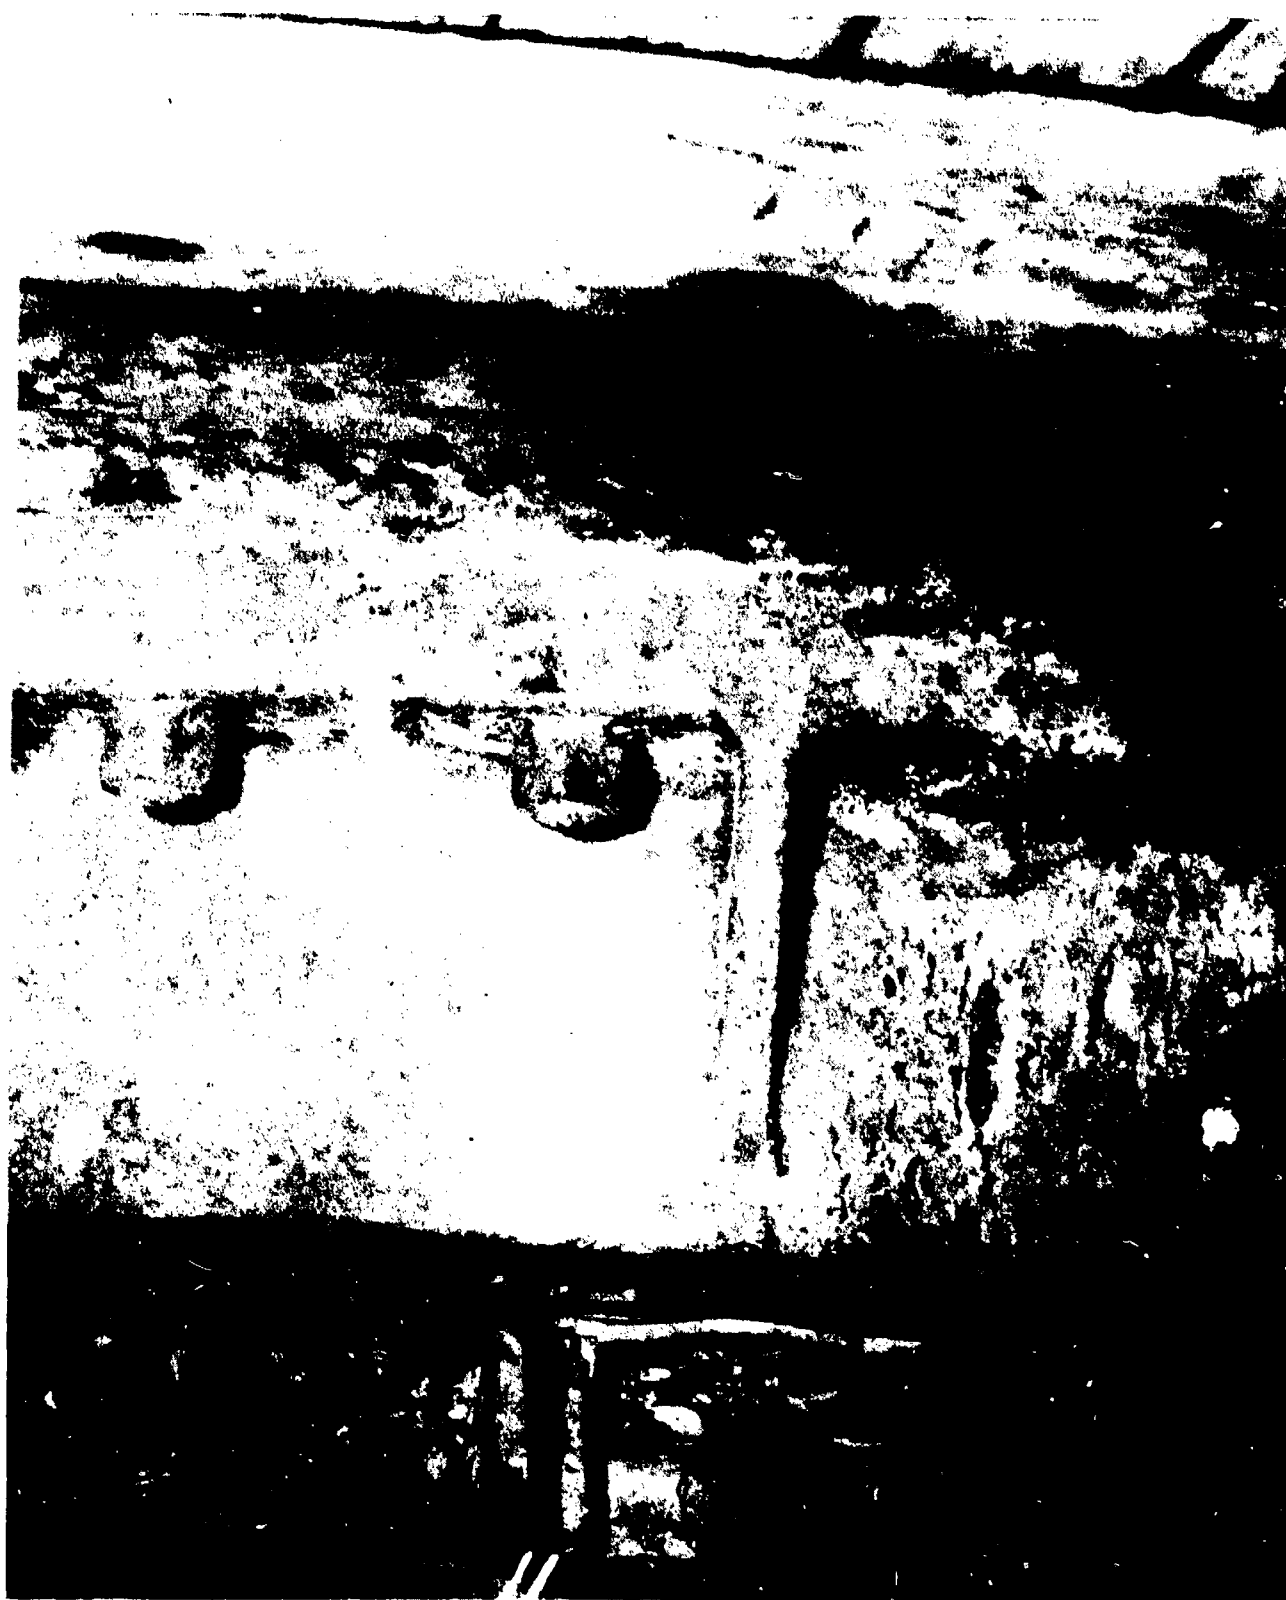
U.S.S. PENSACOLA (CA-24) - After Baker
Close up view of the after section under
the overhang of 8"/55 Cal. Mt. No. 1
showing the torn weather seal housing.
Photo. No. AB-CR-97-1685-11.

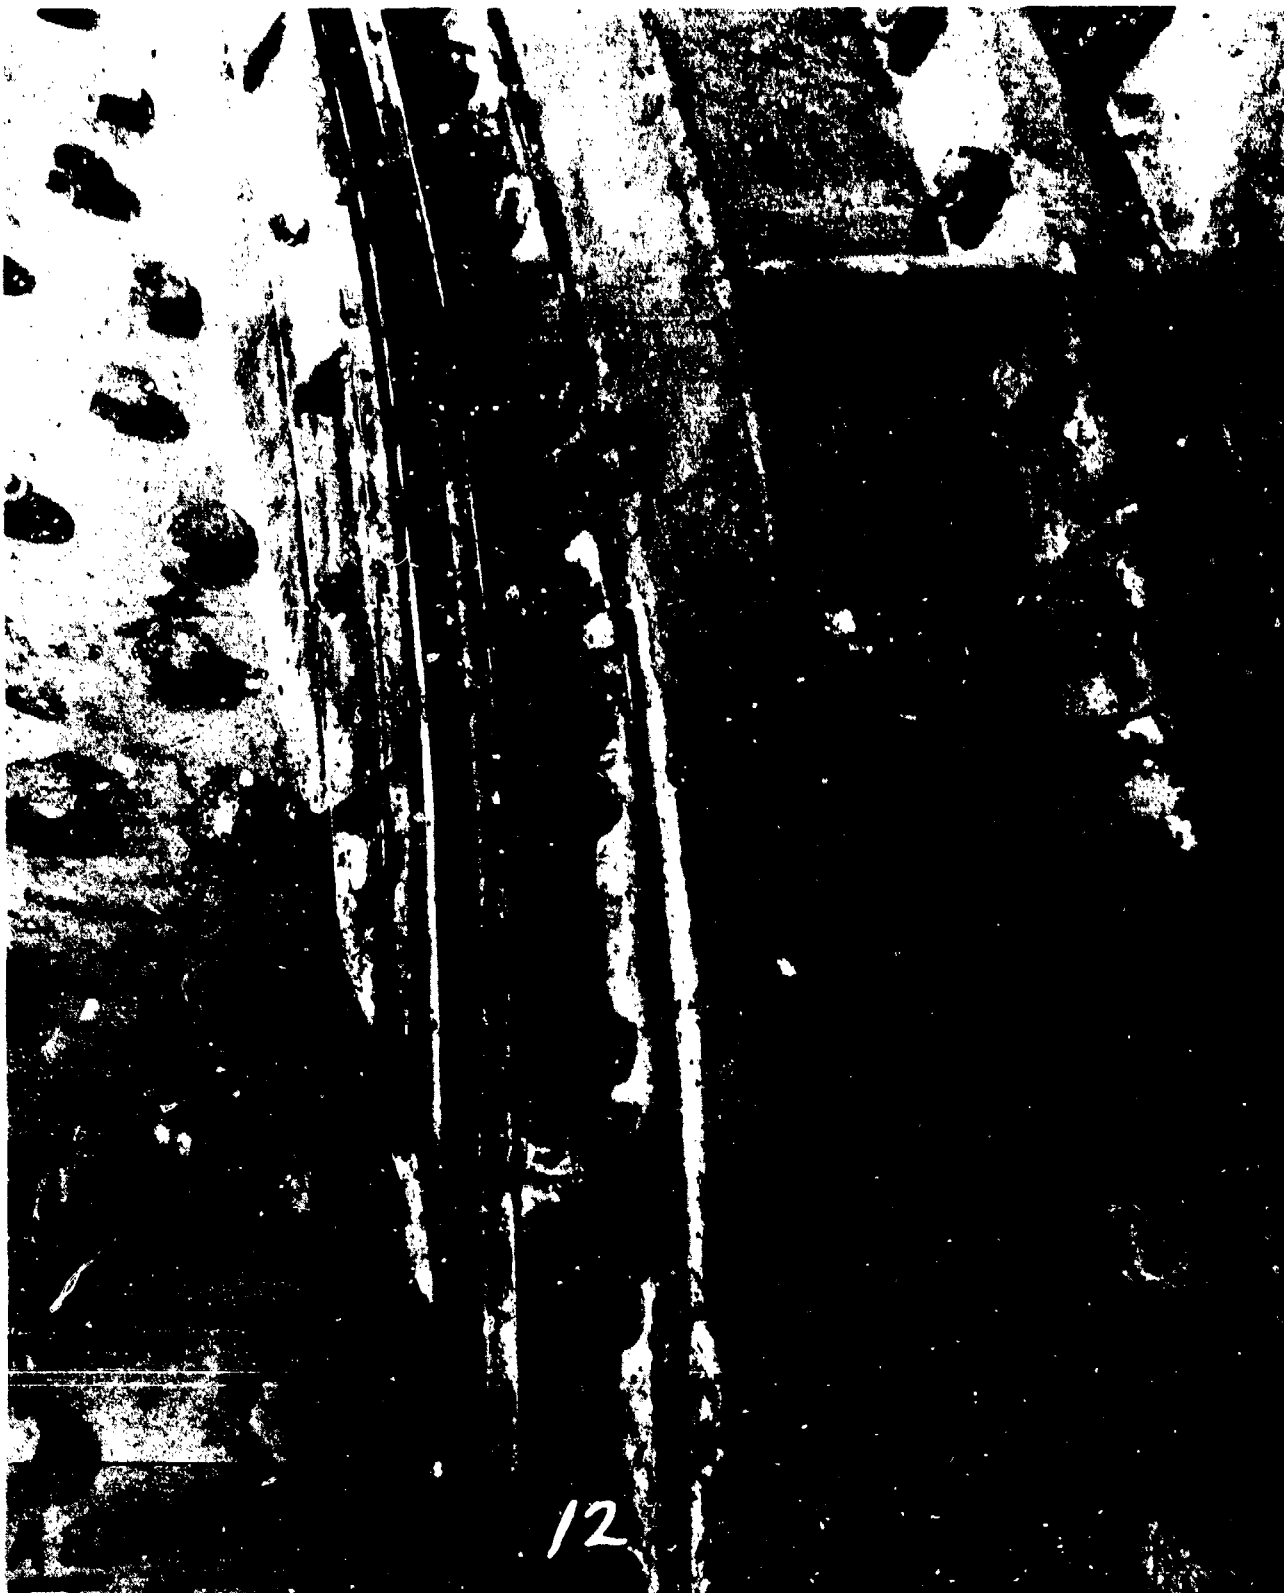
U.S.S. PENSACOLA (CA-24) - After Baker
General view of Port Fwd. Section of the
weather seal on 8"/55 Cal. Mt. No. 1
showing torn weather seal housing and
exposed packing.
Photo. No. ABCR-97-1685-12.

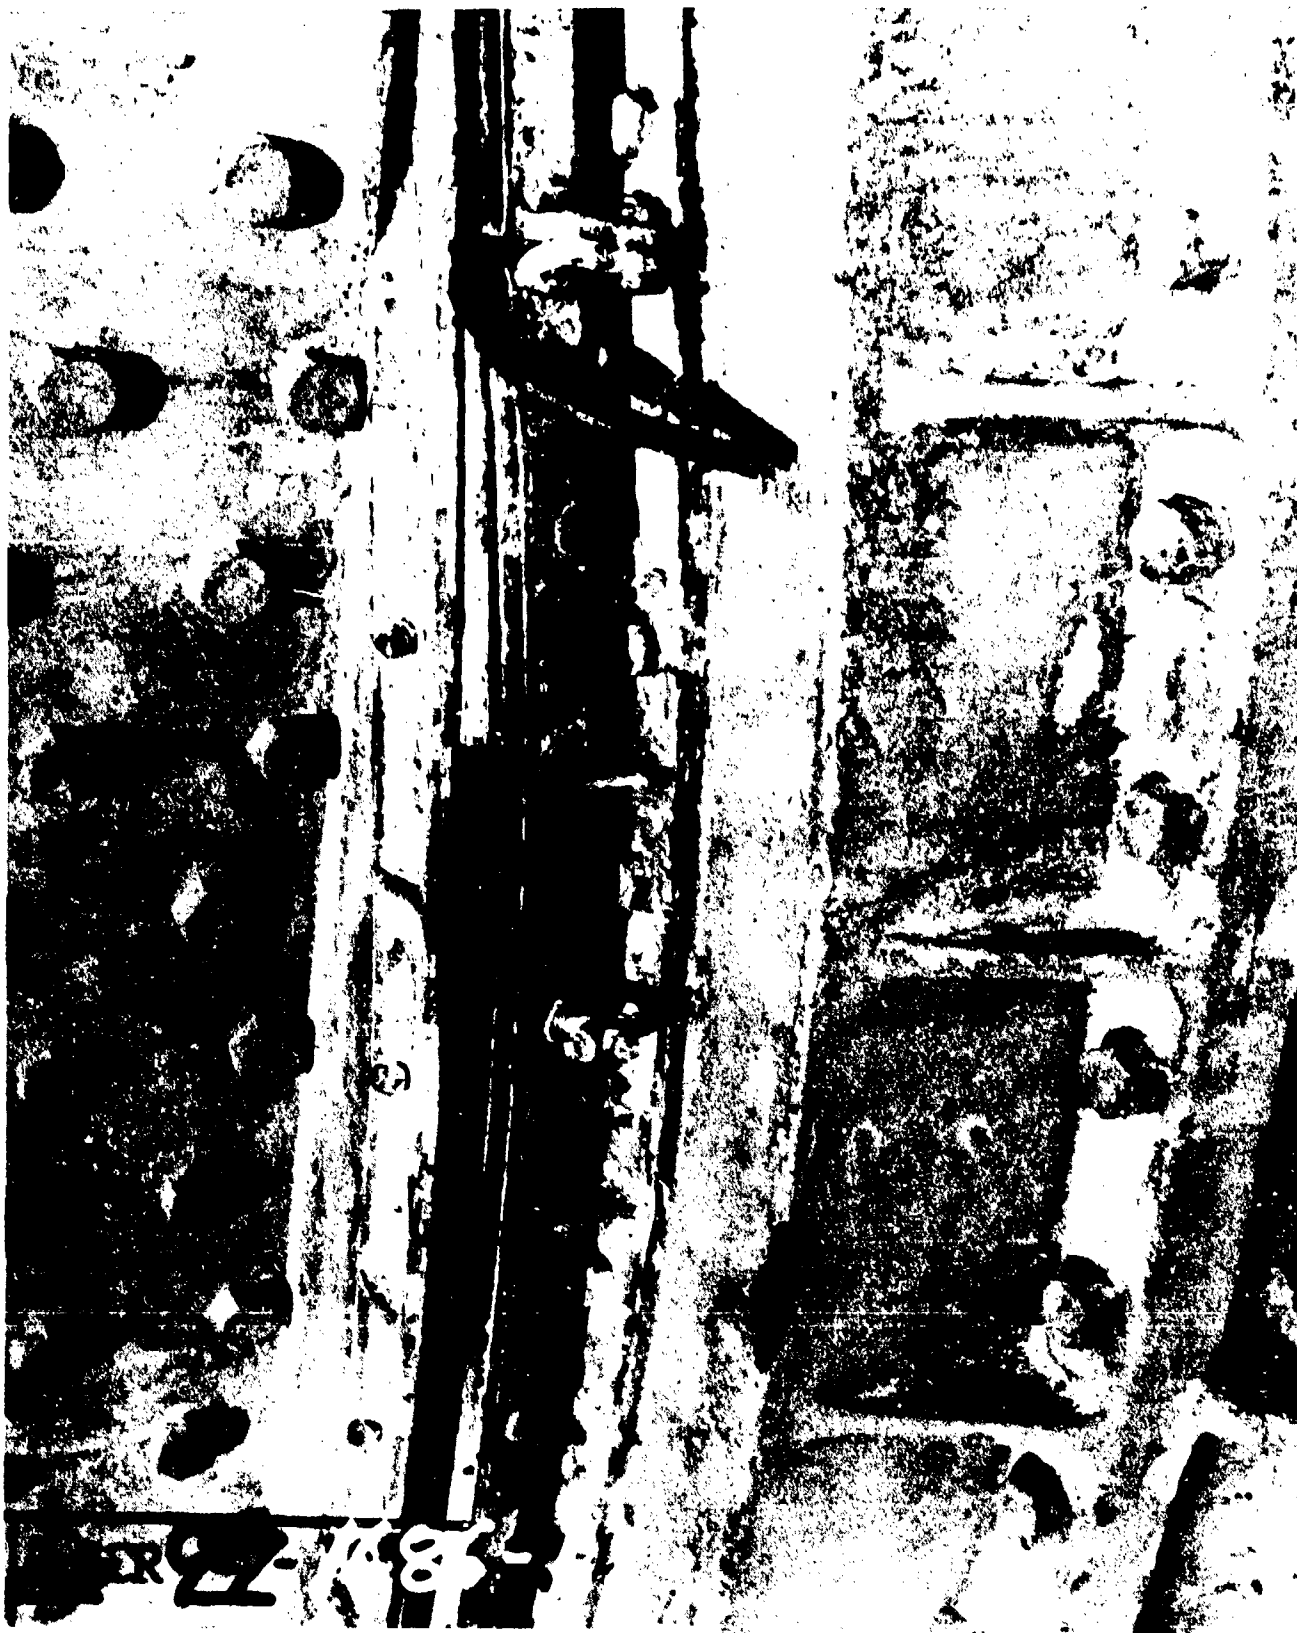
U.S.S. PENSACOLA (CA-24) - After Baker
Close up view of port side weather seal of
8"/55 Cal. Mt. No. 1 showing displaced
weather seal packing.
Photo. No. AB-CR-97-1686-1.

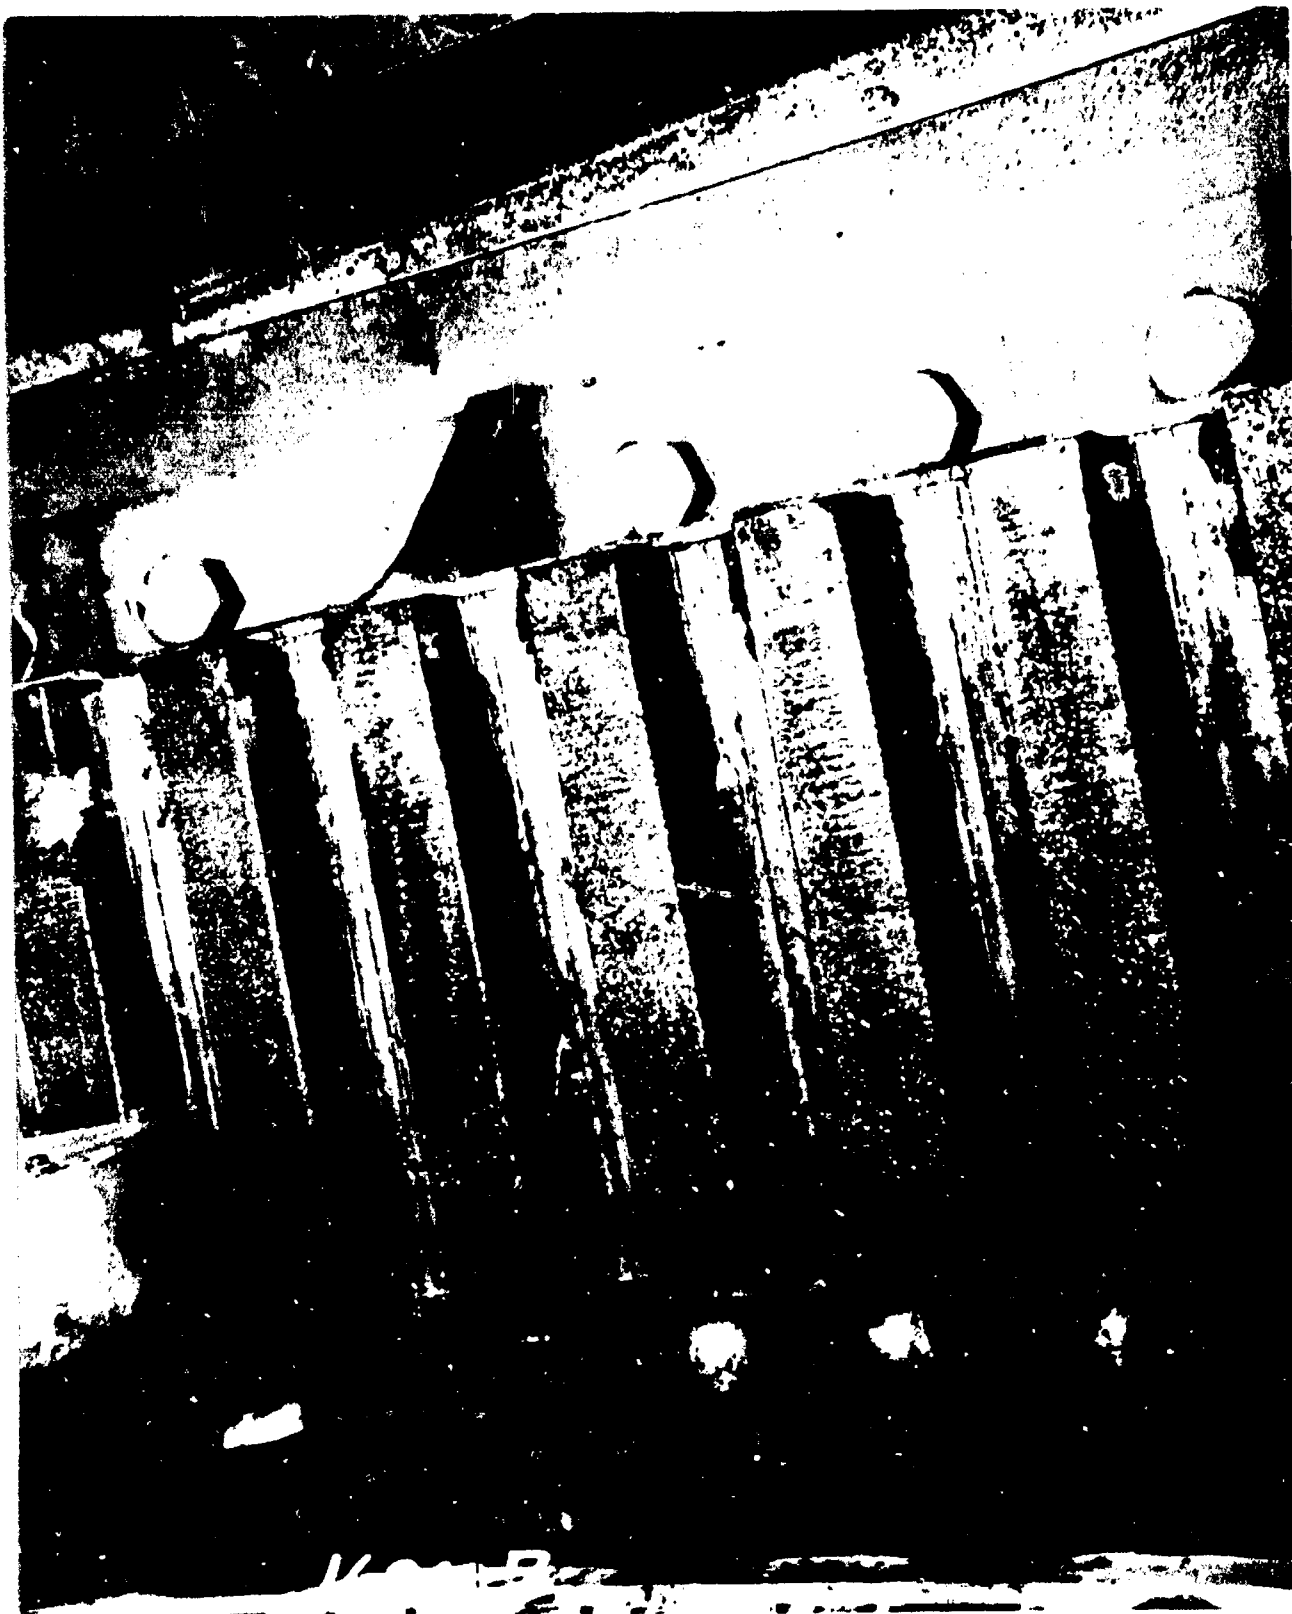
U.S.S. FREEDOM (CR-14) - After looter
Close up view of training rack in 8"/55 Cal.
Mt. No. 1 showing displaced and over lapping
of the Ball Races.
Photo. No. AI-CR-97-1686-7.

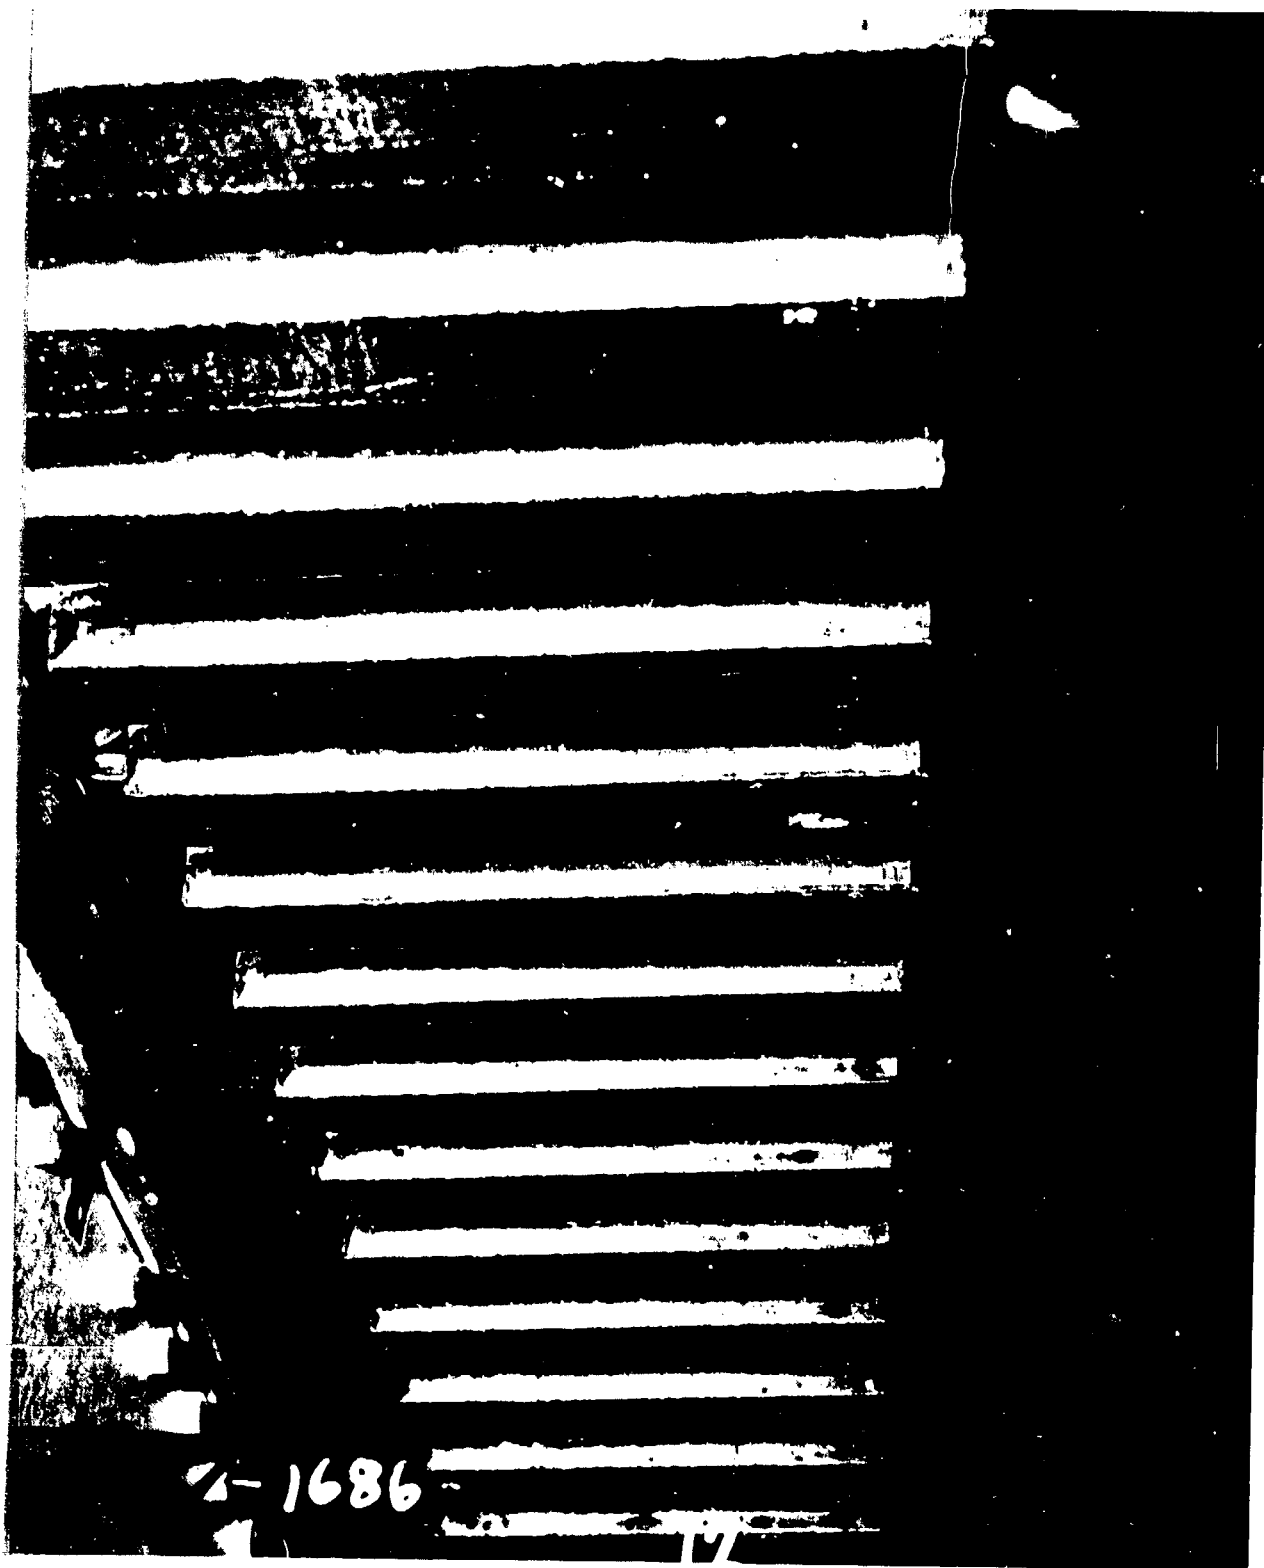
U.S.S. PENSACOLA (CA-24) - After Able
Close up of training rack in 8"/55 Cal.
Mt. No. 1. Showing exposed balls and
ball races.
Photo. No. AB-CR-97-1686-12.

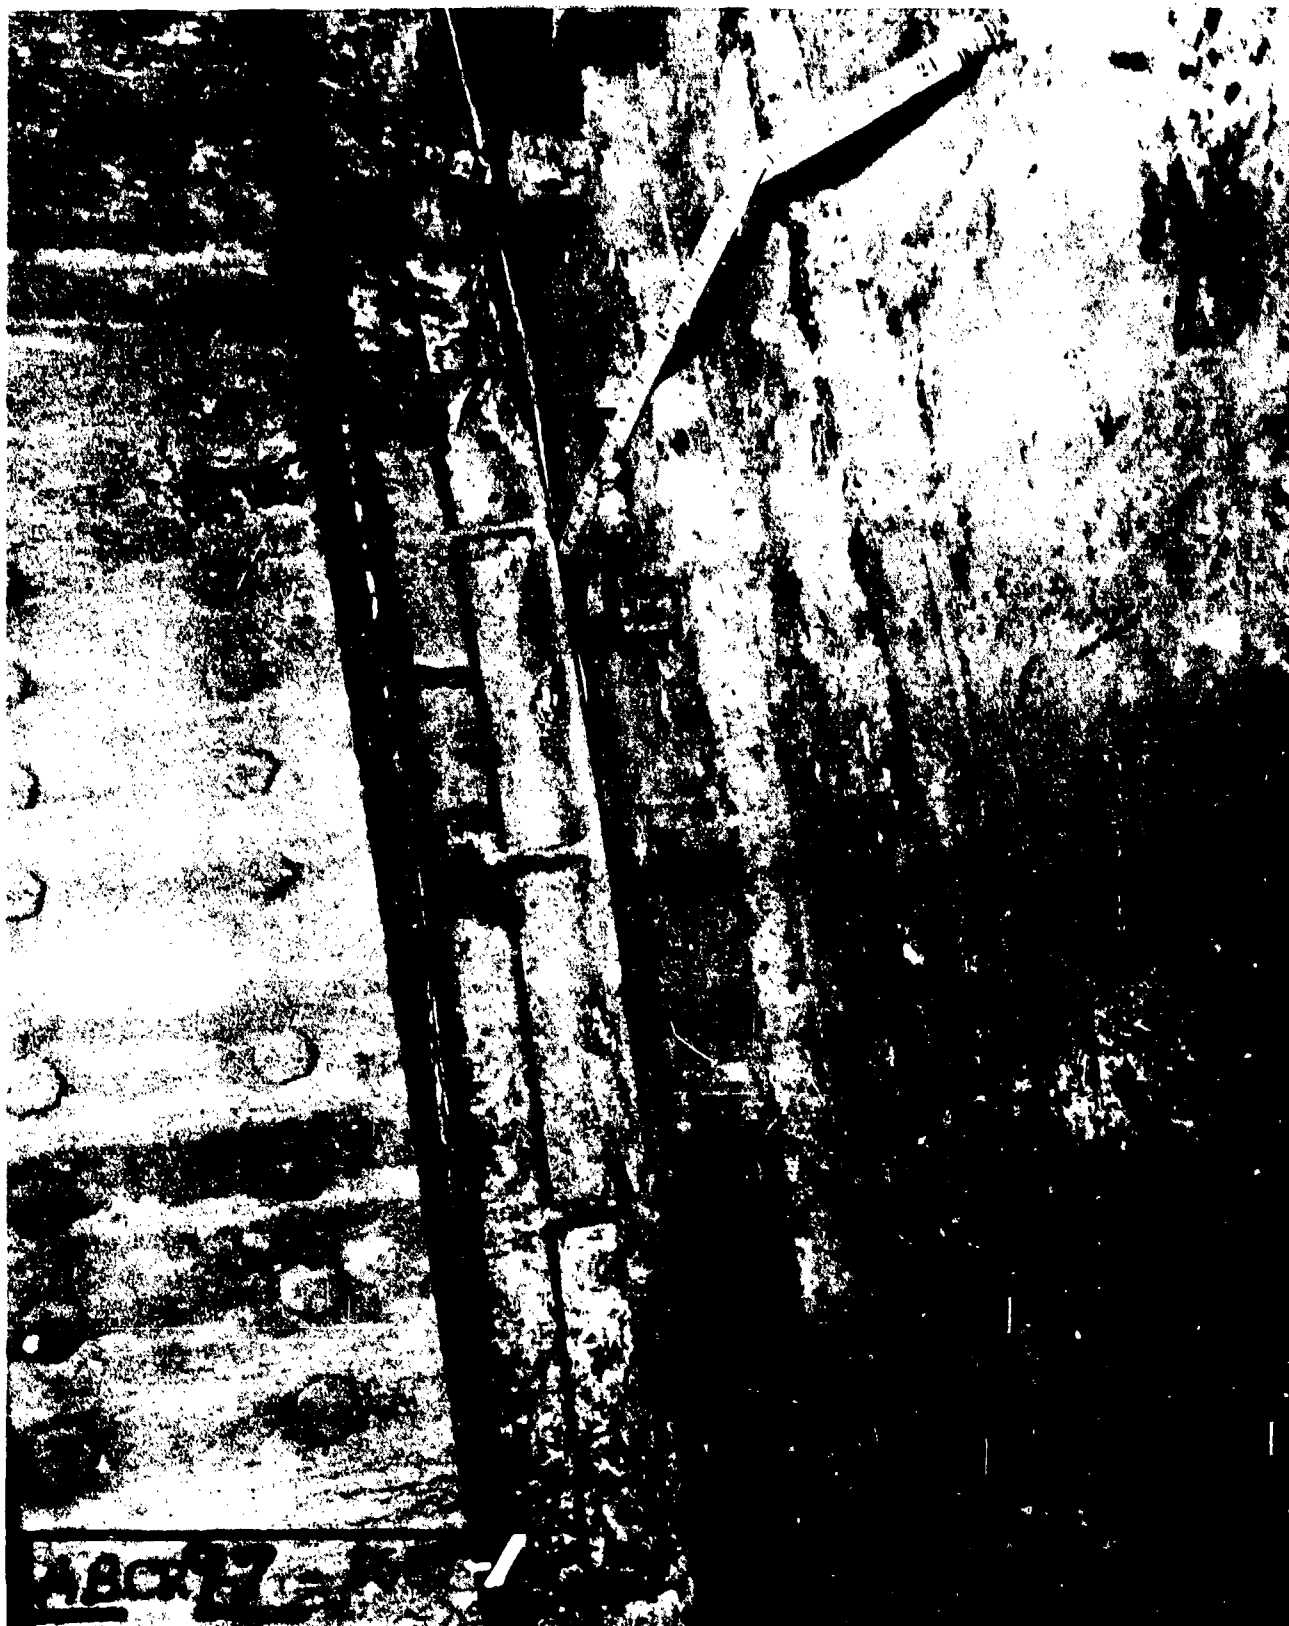
U.S.S. PENACOLA (CA-24) - After Eker
General view of weather seal of Mt. No. 3.
Showing the shifting of the Mt., and altered
bolts. (Starboard side).
Photo. No. AB-CR-97-1687-1.
